TECH NOTE

No. 003

Uneven Fuel Feeding in Single Engine Cessnas

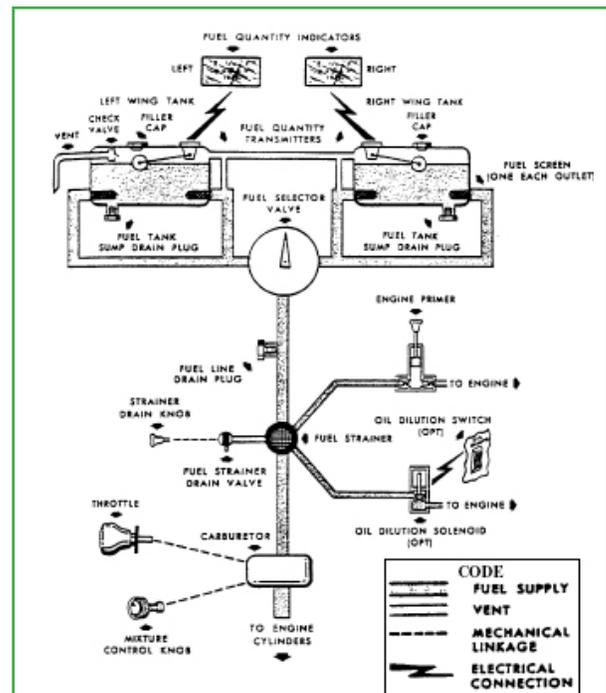
NOTE: The fuel system shown in this schematic is applicable to the Model 182, beginning with serial # 18255786, as well prior serials on which Service Kit No. SK182-38 (thru serial # 18255785) or SK182-41 (thru serial # 18256144)

have worked fairly well except that about the same time, beginning with s/n 18255786 and on, the engineers made another change to the 182's fuel system. Having suspicions that the problem was related to unequal pressures in the tanks, they made an attempt to equalize pressure throughout the system as much as possible by venting the forward

fuel feed lines to the vent interconnect line running across the top of the fuselage. What this actually does is permit fuel to move from one tank to the other any time there is different head pressure in the tanks, even if the fuel level in the tank is below the height of the vent interconnect line. What will happen is that the tank with the higher head pressure will push fuel through the forward fuel feed line up to the vent interconnect line, across the top of the cabin and down into the vent line for the forward fuel feed line of the other tank (See Drawing). There can be a number of causes of this uneven head pressure which will be discussed a little further on.

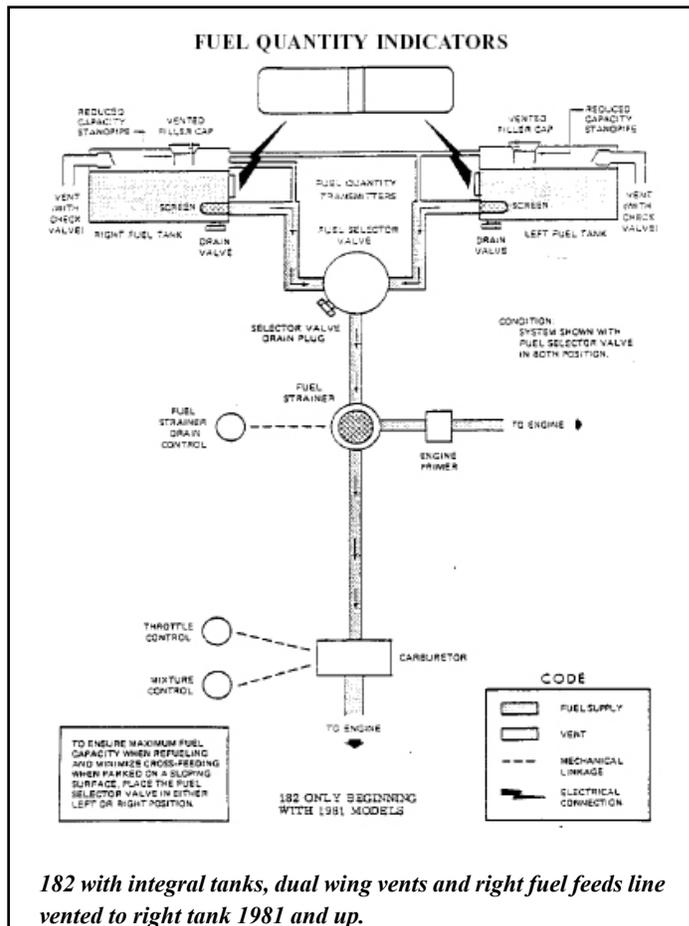
182 with integral tanks, dual wing vents and right fuel feeds line vented to right tank 1981 and up.

Again with the 182 series aircraft Cessna made another change. Beginning in 1981 with serial number 18267716 Cessna rerouted the vent line for the forward fuel feed line on the left tank. No longer did it connect with the vent in-

terconnect line, rather the forward fuel feed line was vented by a line that came from high in the left tank itself. By isolating one of the forward fuel feed lines from the vent interconnect line the passing of fuel from one tank to the other when the fuel level was below the vent interconnect line was stopped. The service manual describes vent position adjustment procedures for evening out fuel flows.

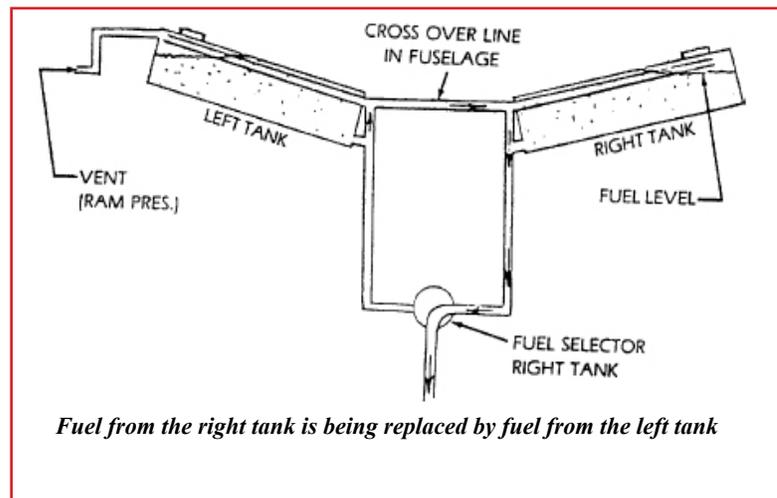
Fuel from the right tank is being replaced by fuel from the left tank

One good thing to note, and it is an important one, is that this is not really a problem of uneven fuel quantities being fed to the engine. Actually the engine is receiving approximately the same amount of fuel from each tank at any given time with the fuel selector in the 'BOTH' position. It appears to be uneven fuel feeding on the gauges because the fuel being used from the right tank is being replaced by fuel
